# **Examples to Support the Housing Health and Safety Rating System**

## INTRODUCTION

These Worked Examples give Model answers for each of the 29 categories of potential housing hazards included in the Housing Health and Safety Rating System (HHSRS). They also include suggestions to improve the conditions and so reduce or remove the hazards described.

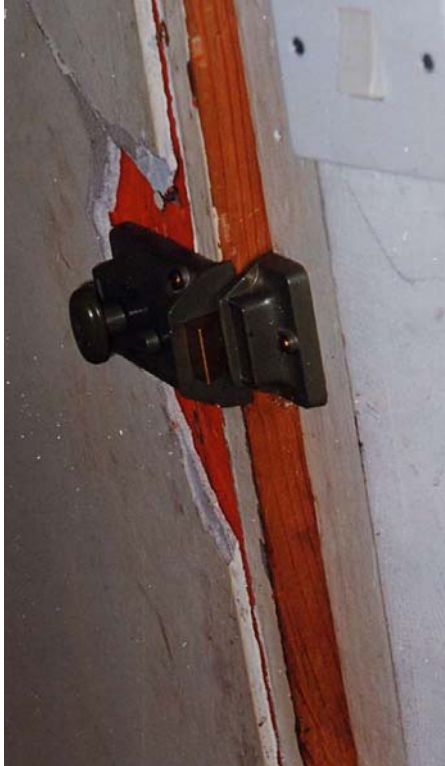
Damaged asbestos sheet around lock .

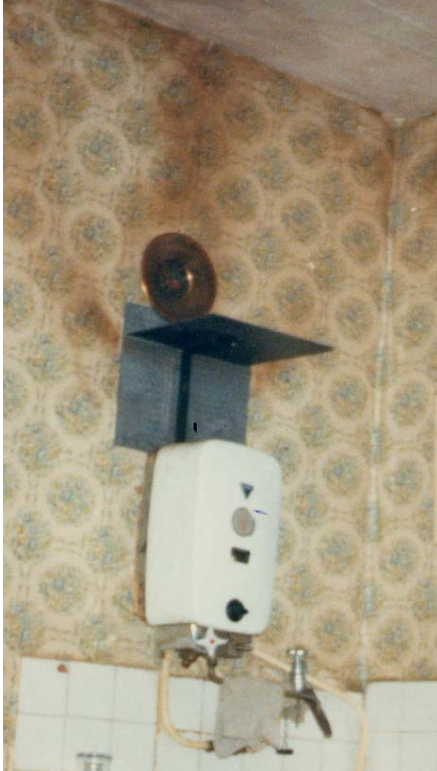
A) Gas instantaneous water heater

The build up of carbon monoxide and other toxic gases in the room and adjacent bedroom increases significantly the risk of a fatal, severe or serious outcome. Together with the high likelihood, this gives a score of 512, a hazard rating of Band D-.

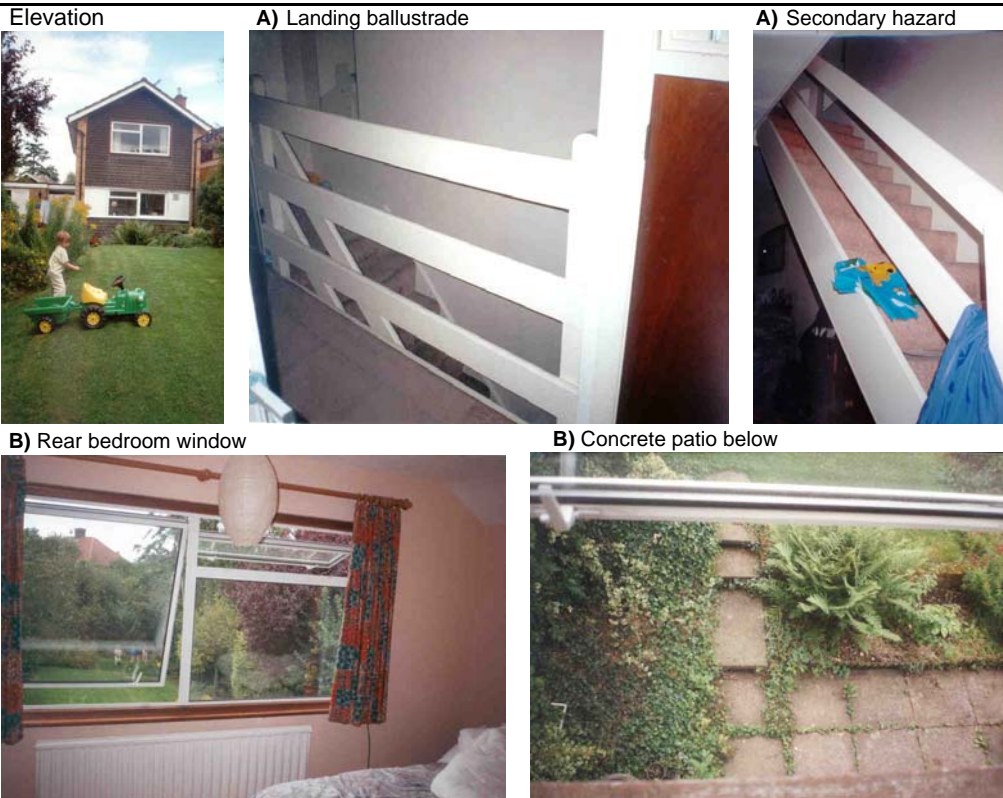
- A) The Landing Balustrade:** This is some 900 mm high and comprises 3 horizontal planks spanning between the top newel post and end post and has continuous horizontal gaps over 200 mm high between. From the landing there is a maximum free fall of some 2 metres to the bottom treads.
- B) Front and rear first floor windows:** Both the front and rear bedrooms windows have a large top-hung opening light, with no safety catch. Both have sills some 850 mm high with radiators below and are some 3.6 m above the ground, which comprises respectively a path and patio of concrete slabs.

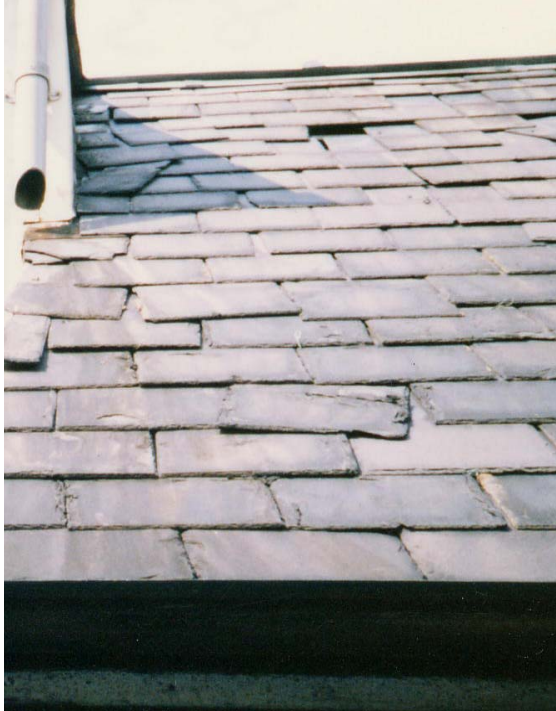
**A) Slipped and missing slates on rear roof**
