# **Examples to Support the Housing Health and Safety Rating System**

## INTRODUCTION

These Worked Examples give Model answers for each of the 29 categories of potential housing hazards included in the Housing Health and Safety Rating System (HHSRS). They also include suggestions to improve the conditions and so reduce or remove the hazards described.

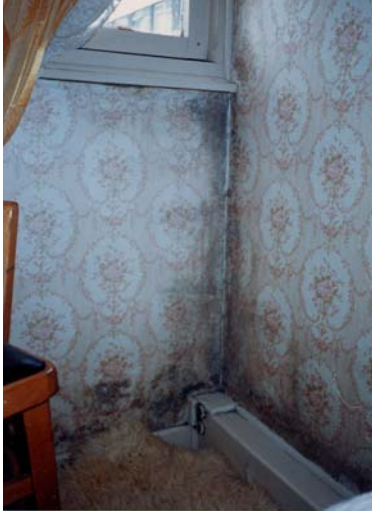
**A) Front end bedroom**

- A) Front bedroom:** The concrete floor to the top floor front bedroom and bathroom projects over the access balcony by approximately 1 metre. There is damp affected plaster and mould growth to the front main walls and to the exterior flank wall to the front bedroom.
- B) Bathroom:** The front wall of the bathroom and adjacent ceiling and internal walls are affected by severe and extensive mould growth, caused mainly by condensation resulting from cold bridging.

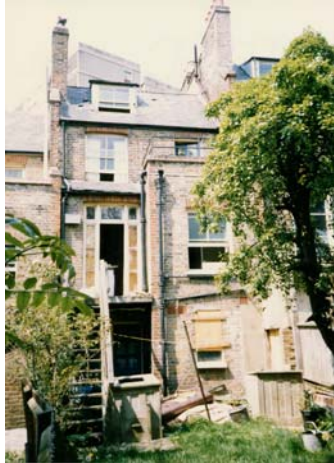
Rear elevation

**A) Rear main wall:** The wall is severely affected by dampness. The roof allows water to soak downwards, and the eavesgutters leak soaking the outside of the wall and allowing water to bounce up from the "patio". The plaster is perished and there is mould growth spreading from the floor.

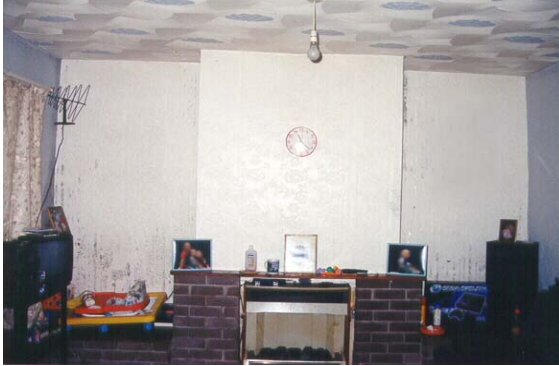
A) Living room

- A) **Living room:** Rising and some penetrating damp with associated mould growth is affecting the external gable wall in both recesses to either side of the fireplace in the living room.
- B) **Kitchen:** Dampness caused mainly by condensation is affecting the whole of the front external wall surrounding the window and adjacent ceiling and party wall in the small kitchen.
- C) **Second bedroom:** Penetrating damp and some associated mould is affecting the end wall.

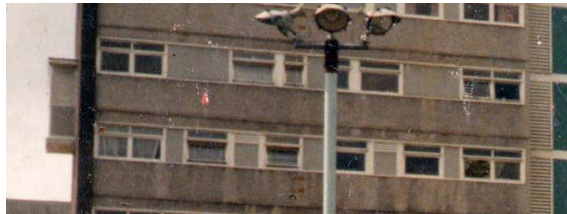
Elevation of maisonette

- A) Heating:** Heating is by electric elements set in the floor slab of the lower floor, with a thermostat control in the living room. The occupier supplements this with portable electric heaters.
- B) Windows and walls:** The windows are single glazed and metal framed. All the windows are centre pivot opening lights, except the bathroom which is a top hung opening light. There is damp and mould growth to the external walls to the upper floor rooms.

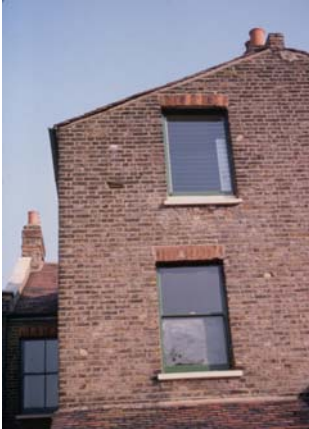
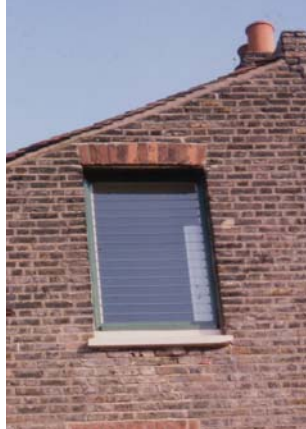
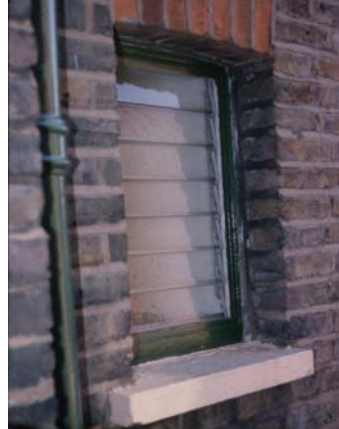
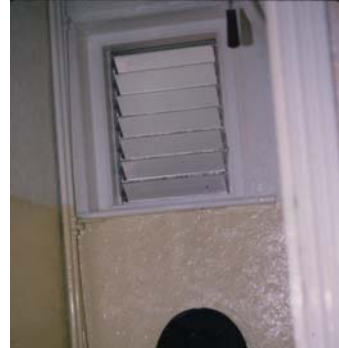
- A) Windows:** Windows to the back addition kitchen, bathroom and w.c. compartment have been replaced with louvred windows. All other windows are single glazed, double hung sashes.
- B) Heating:** The open fireplaces throughout the flat have been sealed. Radiant bar heaters fitted in the front living/dining room, rear bedroom and in the dining area in the back addition.

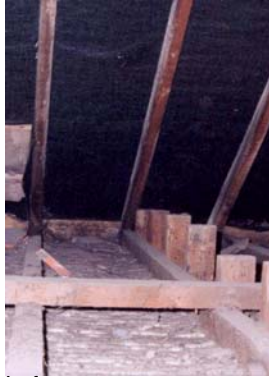
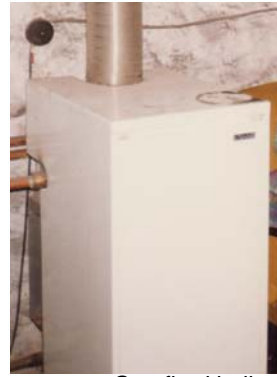
Loft space

**Heating and insulation:** Around 15 years ago, full central heating was installed in the dwelling run from a gas-fired boiler located against the boundary wall in the kitchen extension. The windows, which are mainly sash, are in good condition but single glazed. However, the roof space (where some of the sarking is torn) lacks any form of thermal insulation above the thick lath and plaster ceilings.

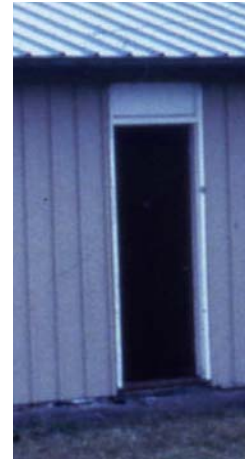
A) Front door

- A) **External walls:** There is evidence that the asbestos sheet insulation to the pre-fabricated wall panels is breaking down. Where the base of the wall panels has broken or is missing, fibrous material has accumulated on the ground. This has occurred at several places on the ground and paths around the base of the house, including positions close to the front door. No hazard warnings are present.

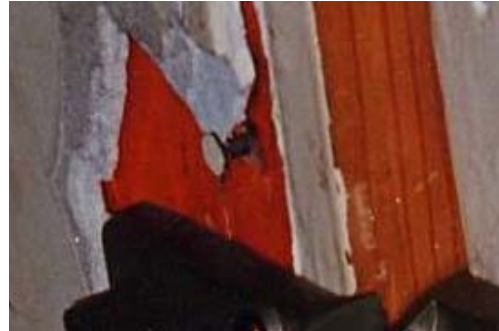
Close up of break showing original fixing

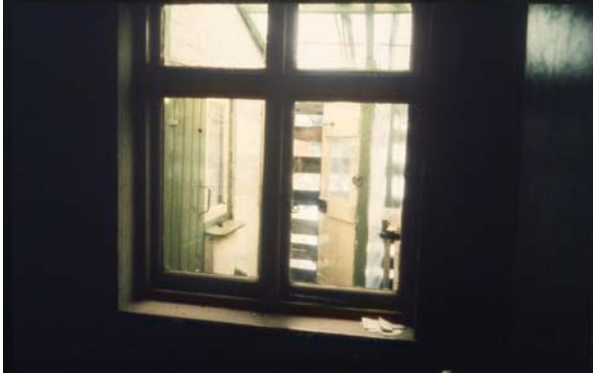
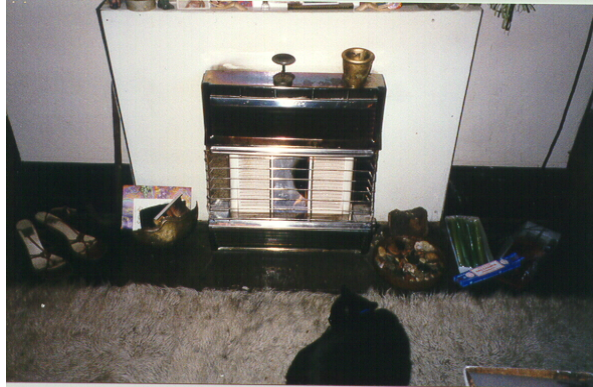
A) Living room window

- A) Gas fire:** The sole source of heating in the principal rear living room is by a fixed gas fire, which has a back boiler serving radiators in three other rooms. The central radiant has burnt through and the fire burns with a reddish flame. (The cooker in the kitchen is electric)
- B) DIY built Conservatory:** The part of the rear yard alongside the back addition has been enclosed, with a corrugated plastic roof and timber studding supporting single fixed glazing. There is no direct ventilation to the rear ground floor living room and the only opening light in the casement window is at high level, the bottom two and one of the upper opening lights having been sealed up. The only external opening to the conservatory is the door.

**Justification** There is no provision for permanent ventilation to the back boiler in the rear room and the gas fire shows signs of incomplete combustion. In practice, although the DIY conservatory is not particularly air tight, the rate of air change is likely to fall well below currently recommended standards when the windows and kitchen and conservatory doors are closed. Consequently, with the incomplete combustion, the risk is much higher than average.

**Justification** Providing permanent ventilation to the back boiler and gas fire and repairing the installation such that the appliance satisfied the relevant Gas Safety (Installation and Use) Regulations would reduce the likelihood and health outcomes to average or below. This would reduce the rating to Band J.

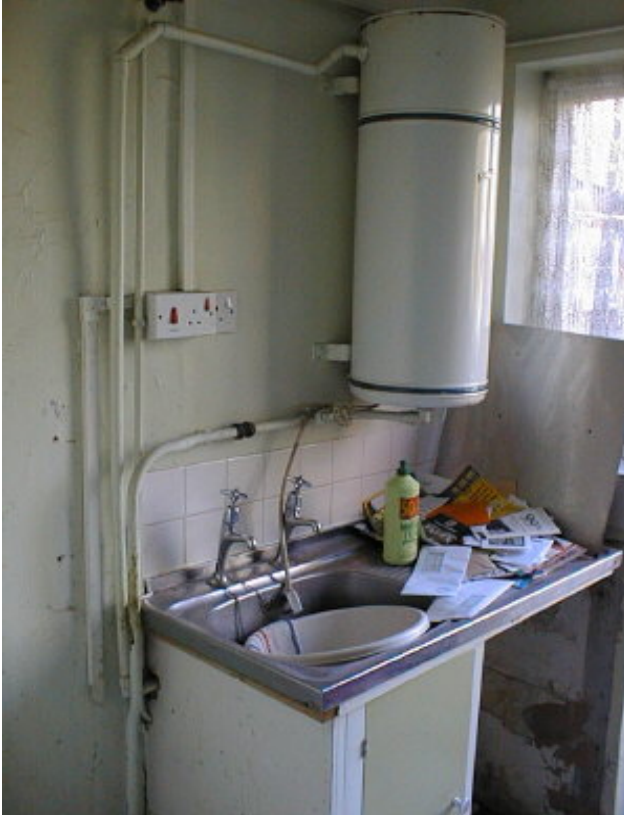
Rear kitchen

- A) Lead paint:** There have been a few improvements and alterations to the house. However, repainting of internal woodwork has not included removal of the original paint and the main lead water supply pipe has not been changed. Much of the internal decoration is worn and peeling, the paint to internal woodwork is chipped in parts and repainting is needed.
- B) Lead pipes:** The water supply pipe serves the cold water tap over the sink and the electric water heater. The dwelling is in a rural area, and water supplies are known to be plumbo-solvent.

**Justification** The internal woodwork is in need of repainting, which, in view of its condition, would involve removal of the old paint down to the bare wood. Without appropriate precautions being taken, this could release old lead-based paint dust and fumes into the dwelling. This combined with the contamination of the water supply would dramatically increase the likelihood of an occurrence. (Without the old paint, the likelihood would be around 1 in 56.)

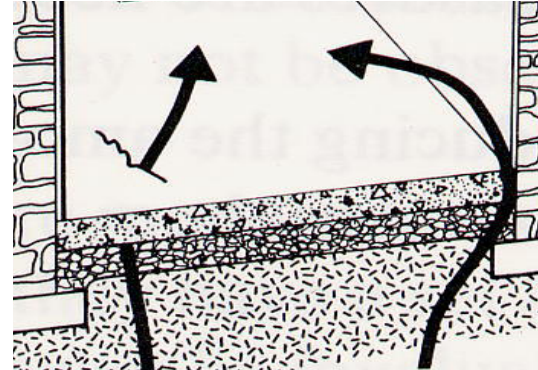
B) Rear dining room floor

**Justification** There is sufficient evidence to suggest a radon problem and subsequent measurements show a level of over 2,000 Bqm<sup>-3</sup>, way above both the average for radon affected areas and the recommended action level of 200 Bqm<sup>-3</sup>. Information from NRPB and other sources (see table overleaf) indicates that this would give an annual risk of cancer of around 1 in 100.

**Justification** The installation of a radon sump under the centre of the house, close to the spine wall, is found to reduce the radon level to just over 70 Bqm<sup>-3</sup> and thereby the likelihood to around 1 in 3,200 and the rating score to 284 - reducing the Band from A to E. As the dwelling is in a high radon gas risk area, some risk remains.

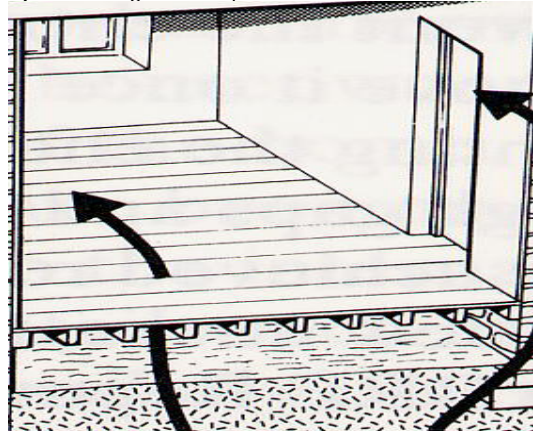
C) Front living room & spine wall

**Justification** There is sufficient evidence to suggest a radon problem and subsequent measurements show a level of nearly 800 Bqm<sup>-3</sup>, substantially above both the average for radon affected areas and the recommended action level of 200 Bqm<sup>-3</sup>. Information from NRPB and other sources (see table overleaf) indicates that this would give an annual risk of cancer of around 1 in 280.

**Justification** In this case, the installation of underfloor mechanical extract ventilation is found to reduce the radon level to 40 Bqm<sup>-3</sup> and thereby the likelihood to some 1 in 5,600 and the rating score to some 160. Thus, the rating band is reduced from B to F. As the dwelling is in a high radon gas risk area, some risk remains.

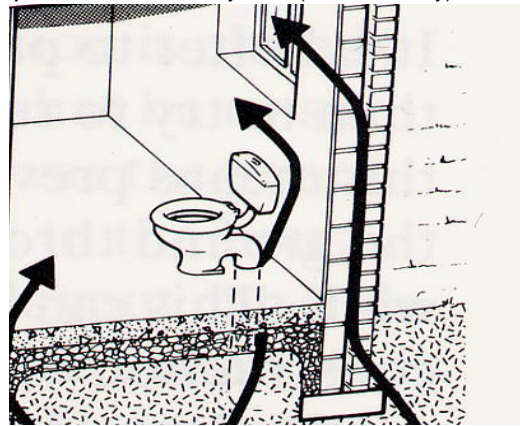
C) Solid floors and cavity walls (illustrative only)

Due to the location of the terrace and its date of construction prior to the introduction of relevant Building Regulations, there is sufficient evidence to suggest a radon problem and subsequent measurements show a level of 196 Bqm<sup>-3</sup> in the example dwelling. Information from NRPB and other sources (see table overleaf) indicates that this would give an annual risk of cancer of around 1 in 1,000.

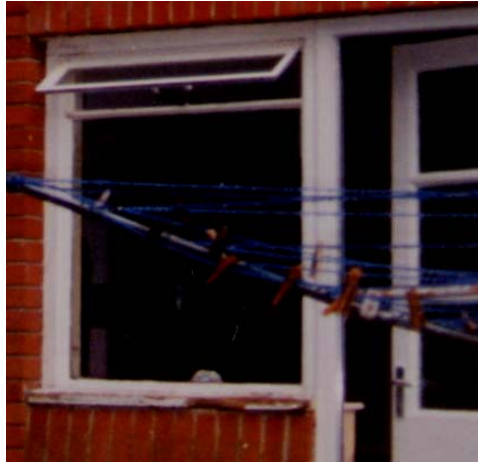
Ground floor rear kitchen/diner

**Justification** The windows to the rear elevation are of adequate size and are well located so that, if unobstructed, the dwelling there would be adequate natural lighting. However, the position and height of the Leylandii hedge obstructs daylight with the result that there is inadequate daylight penetration into the rear rooms. As one of these is the kitchen/diner, the likelihood of a harmful occurrence, is significantly increased. Concerns about getting the hedged removed/lopped may also add to the psychological harm.

**Justification** The hedge should be cut down to a height of less than 2 metres or removed and replaced with a fence. Either of these would remove the obstruction and allow adequate daylight penetration.

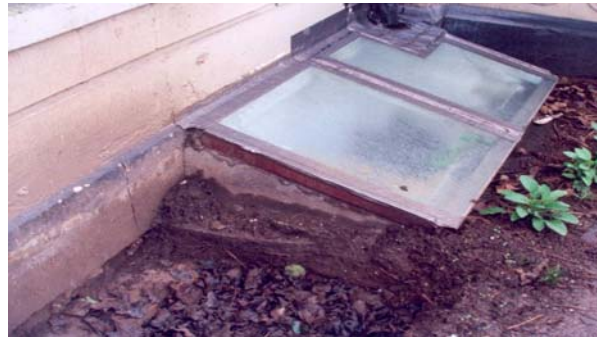
Skylight over front passage

**Justification** Wherever you are in this dwelling, you would be aware that it was built underground. Only the first bedroom provides anything near the natural lighting conditions and outlook that one would expect from a dwelling. The living room has barely adequate light but no outlook, while all the remaining rooms are clearly devoid of both natural light and any outlook whatsoever. Apart from the difficulty of reading without artificial light, it is likely that most people would also suffer some psychological harm from living in the dwelling for a year or more.

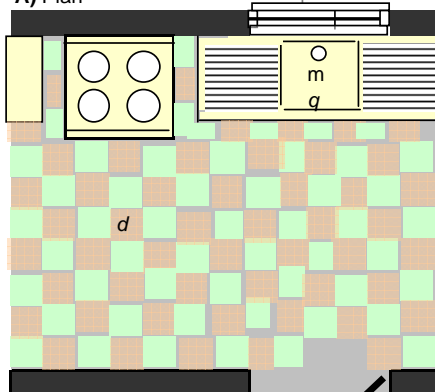
A) Plan

A) **Kitchen floor:** The main photograph shows the kitchen floor looking through an internal door. Throughout the kitchen, the original thermoplastic plastic tiles have become unstuck due to rising damp through the concrete sub-floor and have also become brittle and broken with age. The remaining floors in the dwelling, although similarly damp on the ground floor, do not present any additional risk. In addition (although not shown in the photographs) there are unsealed joints around the service entry points, and, because of the form of construction, potential harbourage within the wall structure, although no current infestation.

**Justification** The extent of the hazard fault and its location increases the likelihood of a major occurrence significantly above that for the average for this hazard. The possibility of the spillage of food and the dampness, together with the difficulties of cleaning, increase the likelihood of the harborage of insects, cockroaches etc, and the risk of infection, particularly to young children. The joints around service entry points will allow access for pests, and the wall structure will also provide harbourage.

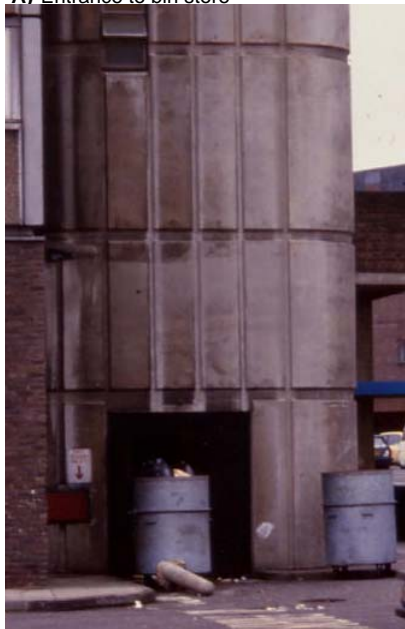
A) Entrance to bin store

**Refuse provision:** Refuse disposal points are sited at the end of the block on every other (odd) floor. These consist of a hopper giving access to a chute which discharges into palladins in the refuse store on the ground floor (see photograph). The hopper on the third floor (used by this maisonette) is broken and has fallen out of the access point. The chute is blocked which has led to refuse building-up inside the chute and refuse being left around the disposal point. The doors to the refuse store on the ground floor are missing and the refuse has accumulated on the floor. Dogs, cats, rats, cockroaches and birds have been seen in the refuse store and around the refuse disposal points. The accumulations are also attracting flies during the warm weather.

**Justification** The chute should be cleared and thoroughly cleansed. The accumulations removed from the refuse disposal point and store. The hopper and access point repaired or renewed. The doors to the refuse store renewed so they can be effectively locked. There should be proper pest control treatment and, although a management issue, there should also be more frequent refuse collection.

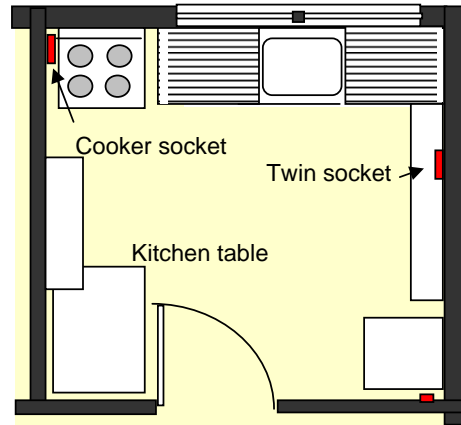
**Kitchen amenities:** The small kitchen measures 2.4 wide by 2.2 metres in depth. A Belfast sink, that is cracked, chipped and crazed, is supported by wall brackets and metal front legs, is positioned under the centre of the window. The sink is supplied with hot and cold water and has worn and scoured wooden drainers on either side. Located adjacent to the left hand draining board is a freestanding electric cooker. The space for the refrigerator is located in the opposite corner. There is a worktop high 300mm deep shelf along one side wall and a low kitchen table. A 1000mm wide wall unit on the other side wall is the only storage unit provided.

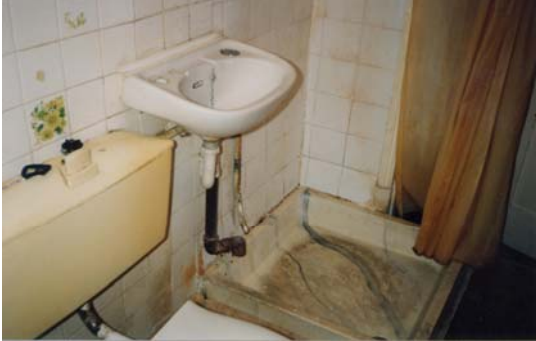
A) Shower room with w.c.

**Justification** The lack of taps to the whb, the location of the basin largely over the shower tray, and the state of the basin all discourage hand washing after using the wc, so significantly increasing the risk of infection. The state of the shower also discourages maintenance of personal hygiene. The room is inconvenient for the ground floor bedsits who may thus use the sink for washing. As all amenities are shared, the risk of spreading infection is increased. Overall, the likelihood of an occurrence is increased substantially for each of the dwellings.

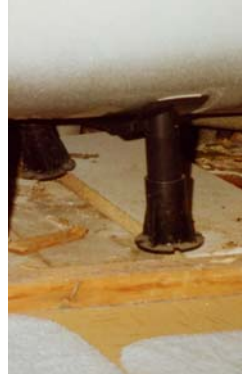
Bath legs at foot

**Bath:** To provide a level footing for the four feet of the bath, old white shelving has been placed over the old uneven floor boards. However, no fixing has been provided and with the use of the bath, the boards have now shifted and the feet become dislodged, causing the bath to be unstable and liable to rock. The bath itself has a narrow rim, no grab rails and a rounded bottom with no patterning to increase friction. Elsewhere on the bathroom floor, plywood has been laid over the uneven boards and varnished, and now covered with loose rugs.

**Justification** The risk of a fall associated with the bath is substantially increased by the fact that it is no longer stable and liable to rock significantly as a person gets in and out of the bath. The risk is further exacerbated by the old fashioned design of the bath, with its deep rounded bottom and lack of surface friction, narrow rim and lack of any grab handles. There is also a danger of slipping on the varnished floor, even discounting the loose rugs, when getting in or out of the bath.

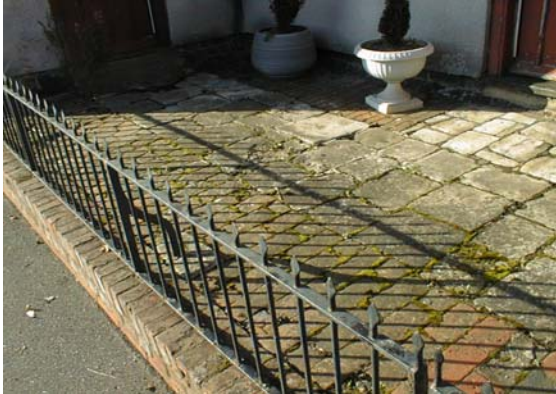
A) Front yard

**Justification** The small rooms and provision of grabrails reduce the likelihood of a fall inside this dwelling to better than average for its age. However, the largely unlit access to both the front and rear doors - the uneven stone and brick paved courtyard at the front, which is likely to be slippery in wet or icy weather, and the unexpected threshold at the rear door and the uneven, cracked and, in places, poorly drained rear yard - is likely to increase this risk substantially.

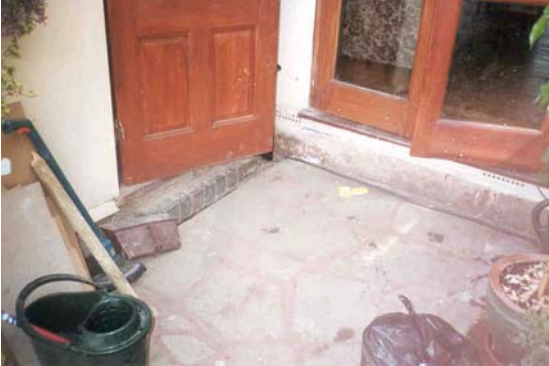
A) Steps to patio and back door

- A) Rear steps:** The kitchen door in the back addition and patio doors to the main rear room both open outwards onto the concrete yard. They open awkwardly over respectively a single grey brick and concrete step/threshold. The patio door is fitted with safety glass.
- B) Floor surfaces:** The floor surfaces in the main rooms on the ground floor, including the area at the foot of the stairs, comprise highly varnished stripped wooden floor boards. There are also some loose boards. The rest of the flooring in the house is typical of the dwelling age and type.
- C) Rear garden:** The rear garden beyond the patio/yard has a surface of rough cast and broken concrete.

**Justification** The way the rear doors open over the threshold and the poor differentiation between the colour of this step and patio surface increase the risk of a fall when exiting to the rear. The loose boards also increase the risk and are a matter for the HHSRS. Although the floors were originally designed to be carpeted, the work to expose and varnish the floors represents a material change to the dwelling and their consequent slippiness an added hazard. The rear garden surface presents another small risk.

**Justification** Providing a wide level platform outside the kitchen and patio doors, repairing and re-carpeting or re-finishing the floor boards to give a less highly glazed, slippery finish and grassing the rear garden would reduce the likelihood of a fall to the average for this age of dwelling.

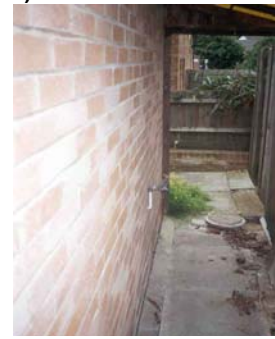
C) Path to rear

**Justification** The risk of a severe accident is increased by the prevalence of hard surfaces and sharp edges around the dwelling and the secondary hazards, particularly, the low brick walls to the porch which are in the possible line of a fall from the front steps and the projecting water tap in the rear wall close to the raised drainage cover.

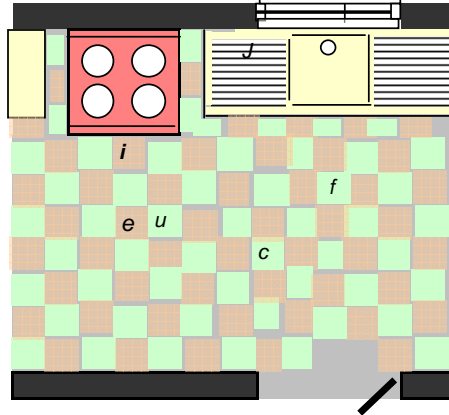
A) Plan

**A) Kitchen floor:** The main photograph shows the kitchen floor looking through the main door leading from the other rooms in the dwelling. Throughout the kitchen, the original thermoplastic plastic tiles have become unstuck due to rising damp through the concrete sub-floor and have also become brittle and broken with age. The remaining floors in the dwelling, although similarly damp on the ground floor, do not present any additional risk with respect to falls on the level and the front access and rear paths are also in reasonable condition. (This floor would also need to be separately rated with respect to provision for food safety)

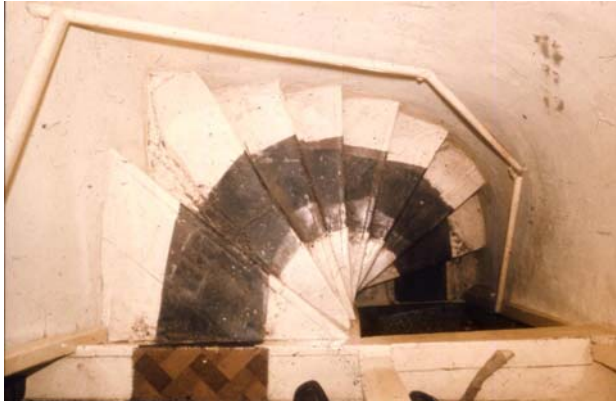
A) Stairs from first floor landing

**Justification** The extreme steepness of the stairs, the uneven angles, tread and riser dimensions and poor handrail, particularly the lack of any handrail or grab rail on the inside of the stairs, together with the lack of natural lighting and inconvenient location of the switches to the artificial lighting, all add to the likelihood of a major accident occurring on these stairs.

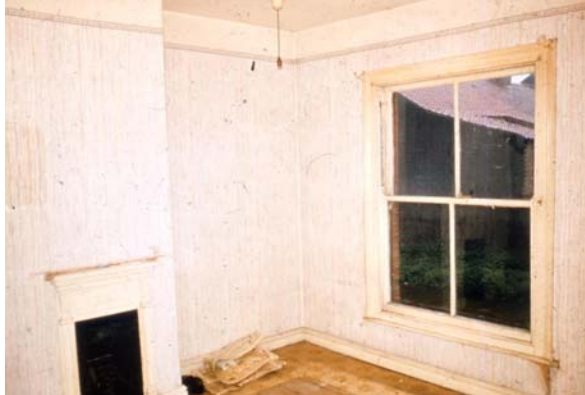
A) First floor front window

**Justification** Although externally the sills are of only average height from the ground, the increased chance of falling through the glass due to the thin glazing, design and disrepair of the windows and the hard concrete surfaces below the two main bedroom windows, heightens the risk of a fatal, severe or serious outcome occurring as a result of a window accident.

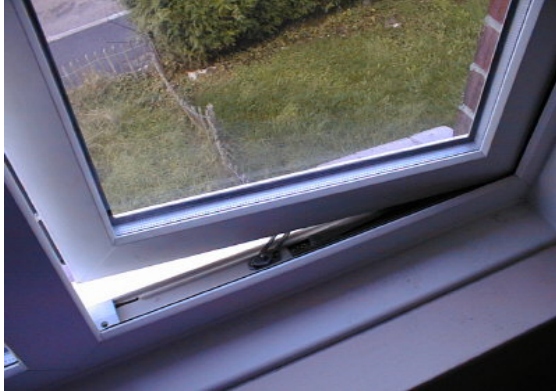
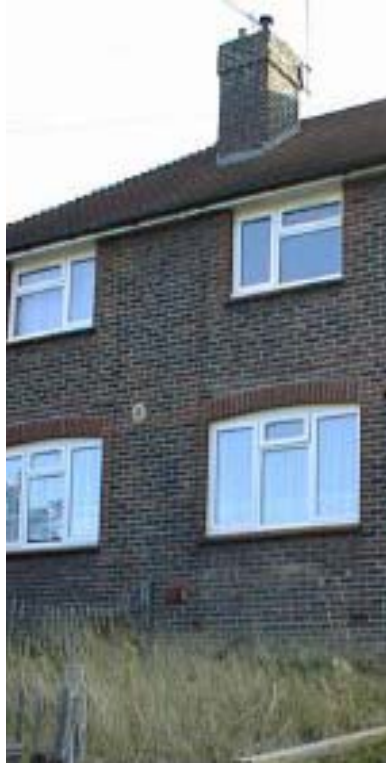
A) First floor front bedroom window

**Justification** Although the sill is at a normal height, it would be possible for a child to use the radiator to climb onto the sill and disengage the safety catch, if the window was left ajar, or for an adult to fall while using the fully open side window to clean the fixed pane. However, with only one such window in the house and this being in the main bedroom, the likelihood of a fall would be no more than average for the stock - that is around 1 in 1,800

**Justification** Depending on how the person falls, he or she will land wholly on the concrete path or kerb, partly on the path or kerb, wholly on the grass, or on the wooden fence. The latter is unlikely given the way the window opens. The first two possibilities appear the most likely and, with the added height due to the sloping site, the chance of a fatal, severe or serious fall is increased to figures above those for the average spread of harms.

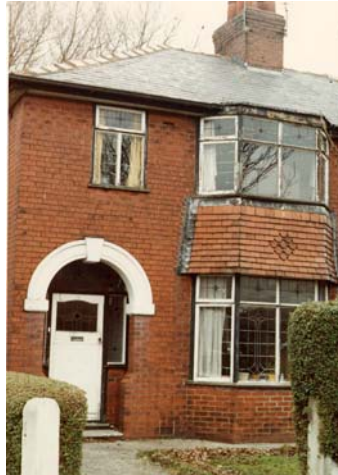
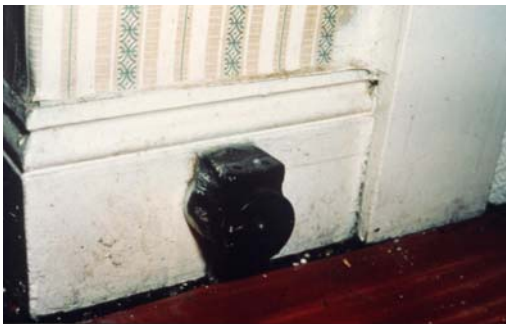
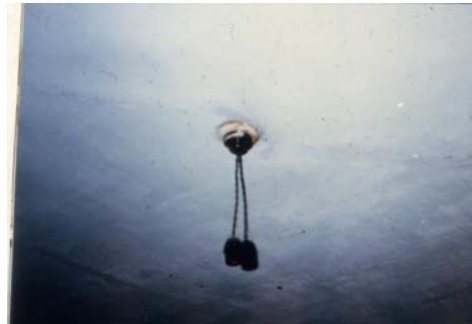
- A) Supply, meter & fuses:** The main supply, meter and fuses are sited at low level in the ground floor hall. The cover on the fusebox is missing and the wiring above the meter is loose and not fully protected. The wiring is mostly lead covered.
- B) Power circuit:** Many of the power outlets have the original two pin sockets, although one newer circuit with flat three pin sockets has been installed to serve the hall and other ground floor rooms.
- C) Lighting circuit:** The photograph shows the two core, fabric covered wiring to a ceiling light, this being typical of the wiring to lights throughout the house.

**Justification** Although the risk of serious electrocution is much higher than average, the spread of harms resulting from this does not change. However, with the very high likelihood of a serious occurrence this would give a high score of 2,935 and a hazard rating of B.

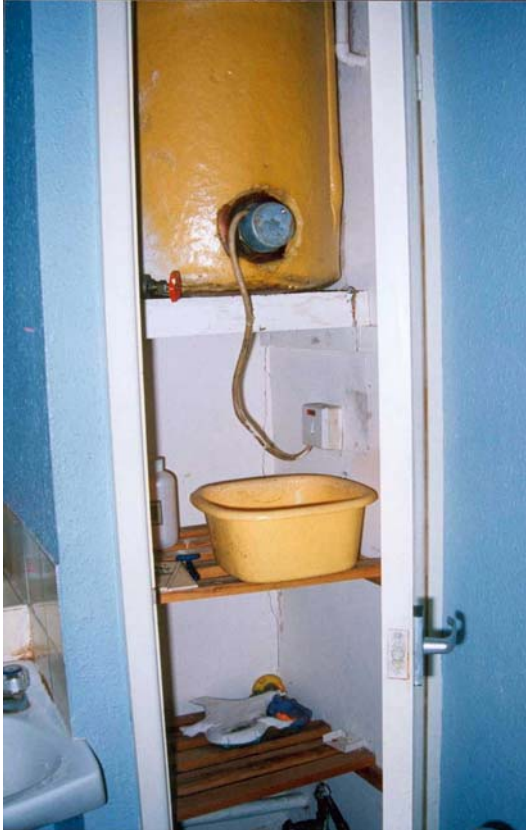
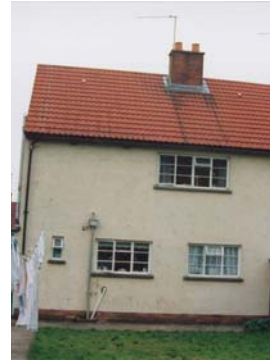
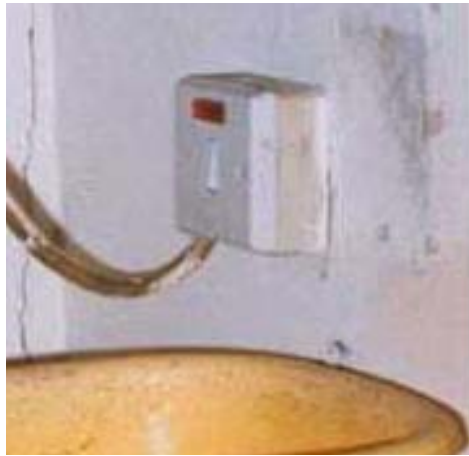
**A) Supply, meter and fuses**

**A) Immersion Heater:-** The gasket around the hole where the immersion heater enters the cylinder has perished resulting in a small but continuous leak. Water is not only running down the loose electric lead to the heater, but also onto the timber shelf holding the cylinder and down the side wall of the airing cupboard on which the switch to the immersion heater is located. The plaster skim and plasterboard above and behind the switch box is now thoroughly soaked. The householder has placed a bowl to catch any directly dripping water.

**Justification** The water seeping into the switch box could give rise to an electrical accident, particularly for adults. However, the greatest risk is to children. To reach the affected area, young children would need to find the cupboard door open and climb the shelving, although the presence of bathroom toys in the cupboard might encourage this. There is a further danger that the loose lead could be used to assist such a climb and pulled away from the heater while switched on.

**Justification** There is a possibility that the water collected in the bowl could be spilt over the child during the climb. This could increase the harm outcomes by, for example, conducting the electricity through the child's clothing. This increased spread of health outcomes on top of the above average likelihood would give a hazard score of 334 and a band E rating.

**Justification** Although the main hazard comes from the switch, this does not appear defective. The immersion heater needs replacing and rewiring to current standards, ensuring that the cable is securely fixed. With no other major electrical installation faults in the house, this would reduce the hazard score to the average for the stock.

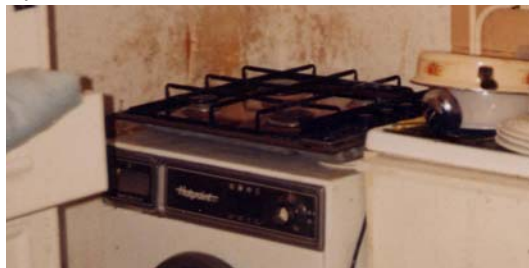
A) Detail of hob

**Justification** **Ground floor rear dwelling:** The siting of the gas hob directly on the washing machine, without any fixing or intervening heat insulation, the loose gas pipe and its position in the extreme corner of the room, close to wooden kitchen fittings, presents a fire risk substantially above the average for pre 1920 flats .

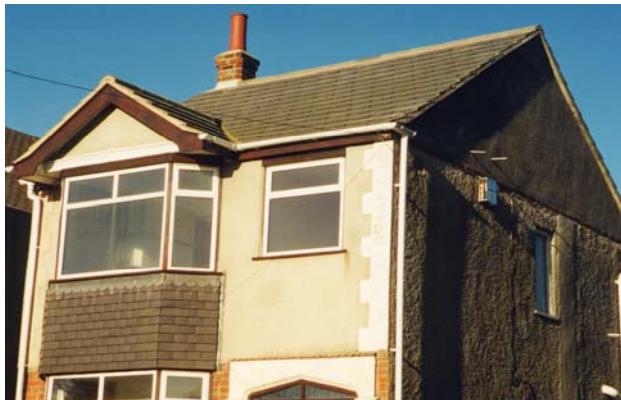
Closer view of main windows

**A) Means of escape:** During the 1950's, the timber framed casement windows to all elevations were replaced with aluminum framed, double glazed units with fixed lights and small top hung opening casements. The main form of heating is open coal fire with back boiler serving radiators to the ground floor only, but this is supplemented by portable electric radiant fires and a paraffin heater. There is an electric cooker. There are no smoke/heat detectors or alarms.

**Justification** The use of open coal fires and, particularly, the supplementary use of portable electric radiant and paraffin heaters which is a direct consequence of the inadequate fixed heating, significantly increases the risk of fire over and above that average for this age of dwelling.

**Justification** The lack of fire detectors and the limited means of escape resulting from the use of fixed glazing in all windows, substantially increases the risk of fatal, severe and serious outcomes occurring as a result of a fire.

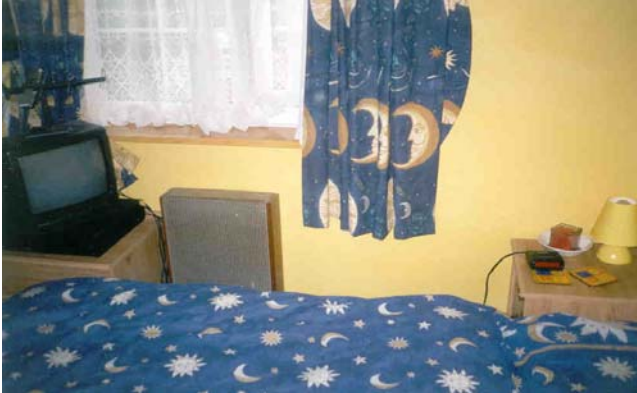
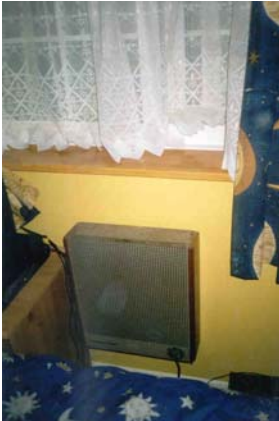
A) Gas heater in bedroom

**Justification** The dwelling has one smoke alarm (albeit battery operated) and generally provides a relatively straightforward and easy means of escape, both through the doors and via the windows. Consequently, in the event of a fire in the bedroom, there is nothing to indicate that the likely spread of harms would be either significantly more or less than average (67% of all occupied dwellings now have smoke alarms).

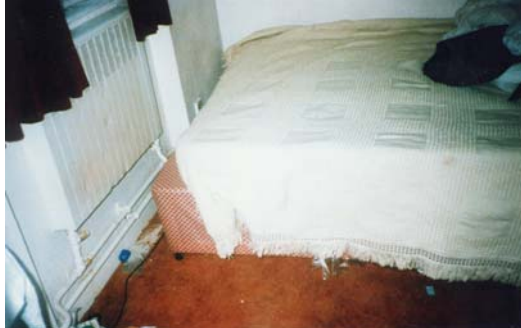
A) Uninsulated central heating pipes

**Justification** As a small child could easily become trapped between the pipes and the bed in the third bedroom, the probability of severe harm is increased.

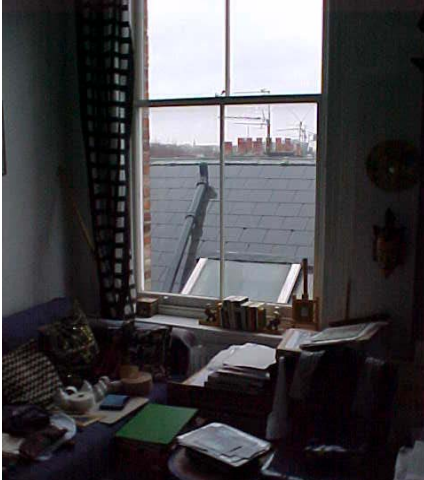
Living room window

The threadbare condition of the sash cords, particularly those of the most frequently opened lower frames, suggests that the remaining cords and particularly that on the sash where there is already a broken cord, could break during the following 12 months. As this is most likely to snap while the window is being opened or closed, the likelihood of harm is increased.

Replacing all the sash cords with new sash cord and adjusting and balancing the sash weights would reduce the likelihood towards the average for this hazard. However, other work is advisable to reduce the risk of falls between levels, such as safety catches, guards, or raising the window sills, and perhaps the installation of safety glass.

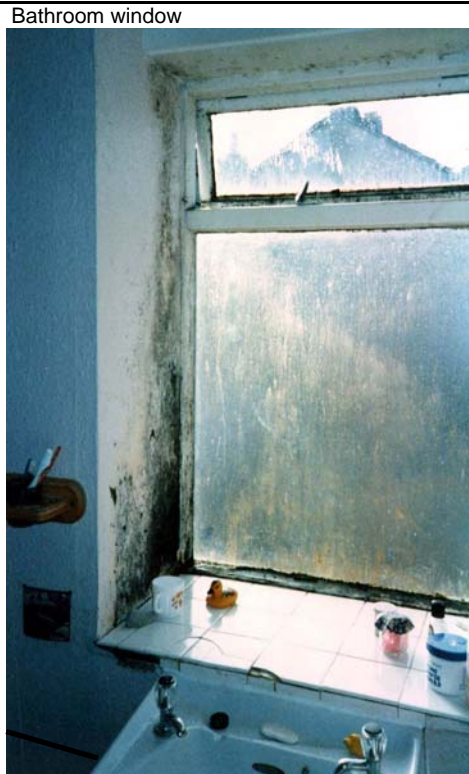
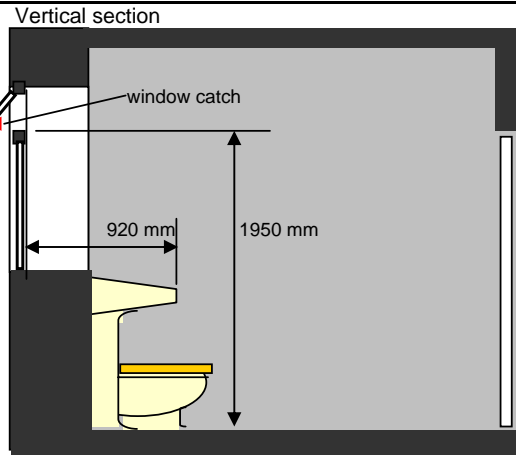
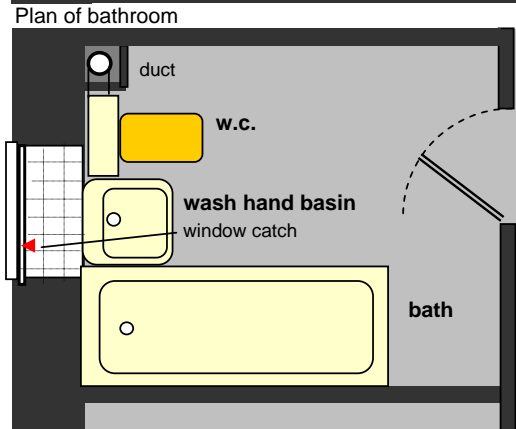
The catch to the top opening light is positioned just under 2 metres above the bathroom floor. This height would be just acceptable, except that to reach the catch in this case also entails stretching over both the full sized wash hand basin and the deep window sill, this being a total horizontal distance of some 920 mm. Without standing on or in the bath, this makes the window catch very awkward to reach and the full opening of the top-hung window virtually impossible for anyone of average height or below.

Although the likelihood is higher than average, the spread of harms is not changed. In terms of poor ergonomics, therefore, the overall risk would be relatively low, the rating score being 52 or Band G-. In practice, a greater risk from this deficiency is likely to arise from the window being consequently left unopened, not just because of its inaccessibility but for reasons of security. This is likely to lead to a further increases in condensation and mould growth.

Resiting the wash hand basin on the internal wall, on the opposite side of the soil pipe and duct, would allow easier access to the window. However, ideally the window should also be replaced with one having a larger opening light and lower catch or, alternatively, to improve security, mechanical ventilation should be installed. This would reduce the HHSRS score to average.

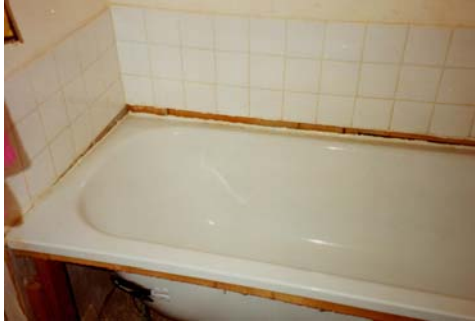
A) Foot of bath

**A) Floor below bath:** The bathroom is on the first floor at the rear of the house above the kitchen. Wet rot in the floor below the bath has caused the boards to rot and some of the end of the floor joists to lose their bearing. The edge of the bath adjacent to the external wall has already dropped by up to 3 cm, resulting in cracks and bulging to the kitchen ceiling below. Immediately below the bath are the kitchen units, which include an electric cooker.
